**Flood Control Project Maintenance  
Levee Inspections**

**Fall 2018 Levee Maintenance Deficiency Summary Report**

<b>RD0544</b>	Overall LMA Rating	Total LMA Miles						
<b>Reclamation District No. 0544 Upper Roberts Island</b>	<b>U</b>	<b>10.20</b>						
Rated Item	Maintenance Deficiency				Enforcement		Design & System Obsolescence	
	M Miles	U Miles	M + 4U Miles	Threshold %	M Miles	U Miles	M Miles	U Miles
<i>Earthen Levee</i>								
Vegetation	1.18	4.95	20.98	205.66%		0.07		
Trim / Thin Trees	0.24	0.09	0.60	5.88%				
Encroachments	0.02	0.02	0.10	0.98%	0.39	0.11		
Animal Control	0.57	0.27	1.65	16.17%				
Slope Stability	0.04	0.01	0.08	0.78%				
Erosion / Bank Caving	0.03	0.09	0.39	3.82%				
Crown Surface / Depressions / Rutting	0.22		0.22	2.16%				
Flood Preparedness & Training	0.10		0.10	0.98%				
<i>Interior Drainage &amp; Piping Systems</i>								
Erosion Areas		0.01	0.04	0.39%				
<i>Supplemental</i>								
DWR Erosion Survey	0.04		0.04	0.39%				
DWR UCIP Field Study					0.19	0.05		
<i>LMA Totals:</i>	2.44	5.44	24.20	237.22%	0.58	0.23	0.00	0.00

**Flood Control Project Maintenance  
Levee Inspections****LMA District Cover Sheet****Fall 2018 Levee Inspection Results****Rec

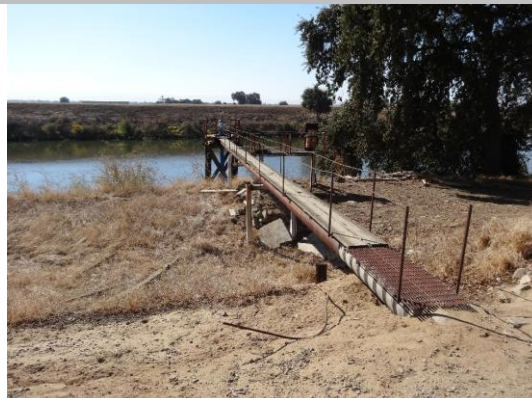
Photo 1 of 3 : UCIP\_FA\_2018\_41731\_42954.jpg

Comment Code					
Inspector Comment					
FS_ID:41731 DS_ID:22675 EP_NO: N/A Repair Type: Non-Urgent Crossing Status: Found UCIP Comments: - soil erosion on landside slope.- new pump and pipe (according to the owner- three months old)- electric conduit through levee, service pole on landside. FIELD_STRUCT_DESC: 16-inch steel irrigation discharge pipe and electrical conduit through the levee, 3 feet below the crown. Pump on a pile structure in the stream. Pressure breaker on the landside (LS) slope. Pipe exposed on both slopes and on the berm. [Additional Reference(s): DWR Levee Log, 2005, 12-inch pipe referenced. USACE San Joaquin O&M Manual 7, April 1964, (HLM 2.25), 12-inch pipe referenced]. FS Date: 10/31/2013

WS view: pipe, walkway, and pump on pile structure.

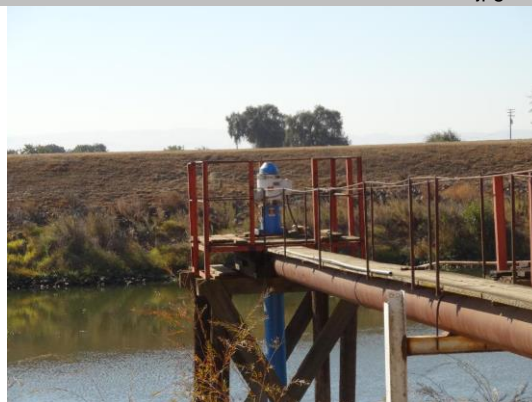
Photo 2 of 3 : UCIP\_FA\_2018\_41731\_42953.jpg

WS view: closer view of pipe, walkway, and pump on pile structure.

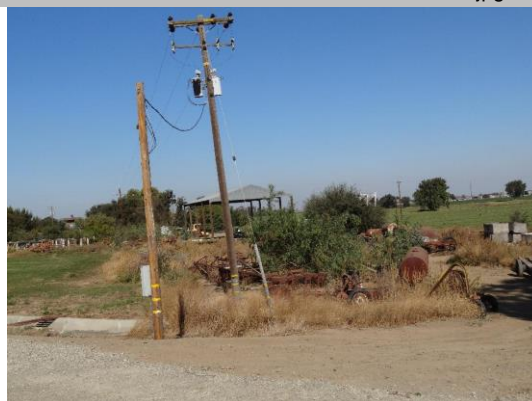
Photo 3 of 3 : UCIP\_FA\_2018\_41731\_42957.jpg

Comment Code						
Inspector Comment						
FS_ID:41731 DS_ID:22675 EP_NO: N/A Repair Type: Non-Urgent Crossing Status: Found UCIP Comments: - soil erosion on landside slope.- new pump and pipe (according to the owner- three months old)- electric conduit through levee, service pole on landside. FIELD_STRUCT_DESC: 16-inch steel irrigation discharge pipe and electrical conduit through the levee, 3 feet below the crown. Pump on a pile structure in the stream. Pressure breaker on the landside (LS) slope. Pipe exposed on both slopes and on the berm. [Additional Reference(s): DWR Levee Log, 2005, 12-inch pipe referenced. USACE San Joaquin O&M Manual 7, April 1964, (HLM 2.25), 12-inch pipe referenced]. FS Date: 10/31/2013

LS view: service pole on levee slope.

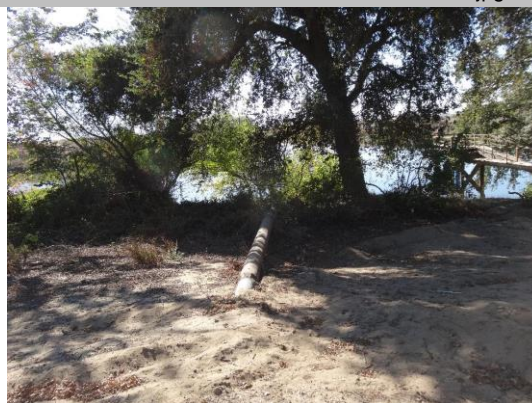
Photo 1 of 3 : UCIP\_FA\_2018\_24293\_42965.jpg

LM Start	2.29	Rating **	M	Issue No.	108
LM End	2.29	Issue Type +	En	Location *	
Category	Supplemental			GPS Latitude/Longitude	
				Start	End
Item	DWR UCIP Field Study			37.821628 °	37.821628 °
				-121.347016 °	-121.347016 °
DWR ID	22676				
Comment Code					
Inspector Comment					
FS_ID:24293					
DS_ID:22676					
EP_NO: N/A					
Repair Type: Non-Urgent					
Crossing Status: Found					
UCIP Comments: Pump not found on the landward side.					
FIELD_STRUCT_DESC: 10-inch steel drainage discharge pipe through the levee, 3 feet below the crown. Pump on the landside (LS). No flap gate on the waterside (WS) end. Air vent on the LS. [Additional Reference(s): DWR Levee Log, 2005. USACE San Joaquin O&M Manual 7, April 1964, (HLM 2.33)].					
FS Date: 10/31/2013

WS view: exposed steel pipe on berm.

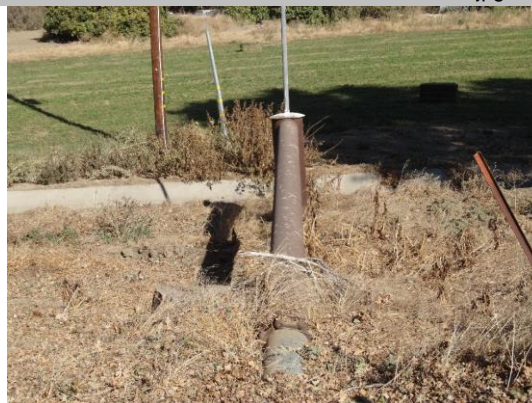
Photo 3 of 3 : UCIP\_FA\_2018\_24293\_42966.jpg

LM Start	2.29	Rating **	M	Issue No.	108 (cont)	
LM End	2.29	Issue Type +	En	Location *		
Category	Supplemental			GPS Latitude/Longitude		
				Start	End	
Item	DWR UCIP Field Study			37.821628 °	37.821628 °	
				-121.347016 °	-121.347016 °	
DWR ID	22676					
Comment Code						
Inspector Comment						
FS_ID:24293 DS_ID:22676 EP_NO: N/A Repair Type: Non-Urgent Crossing Status: Found UCIP Comments: Pump not found on the landward side. FIELD_STRUCT_DESC: 10-inch steel drainage discharge pipe through the levee, 3 feet below the crown. Pump on the landside (LS). No flap gate on the waterside (WS) end. Air vent on the LS. [Additional Reference(s): DWR Levee Log, 2005. USACE San Joaquin O&M Manual 7, April 1964, (HLM 2.33)]. FS Date: 10/31/2013

LS view: exposed steel pipe and air vent on levee berm. No pump found.

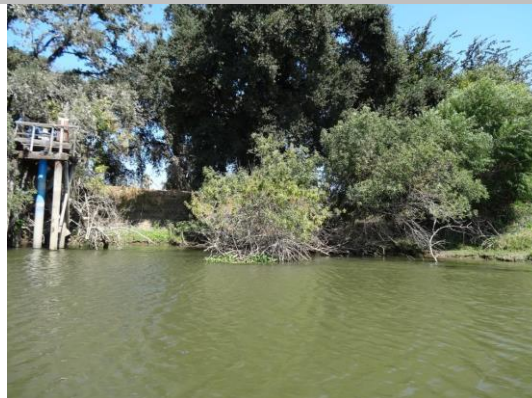
Photo 1 of 3 : FA\_2018\_RD0544\_109\_11\_20180906\_00012.jpg

LM Start	2.31	Rating **	M	Issue No.	11
LM End	2.31	Issue Type +	Ma	Location *	WS
Category	Supplemental			GPS Latitude/Longitude	
				Start	End
Item	DWR Erosion Survey			37.821763 °	37.821763 °
				-121.347275 °	-121.347275 °
DWR ID	RD0544U02RM33.21				
Comment Code					
Inspector Comment					
09/13/2017: No significant change observed.					
07/25/2016: No significant change observed.					
06/25/2015: No significant change observed.					
07/02/2014: No significant change observed.					
08/20/2013: No significant change observed.					
08/07/2012: The site was first reported in 2012 spring levee inspection report. The data were estimated as the site is underneath a irrigation pump station and inaccessible by boat or land survey. It's possible the pump station played a role in the erosion. [2017 Site ID:RD0544U02RM33.21]

Front view of the erosion site. View is partially blocked by the pump structure and vegetation at the site.

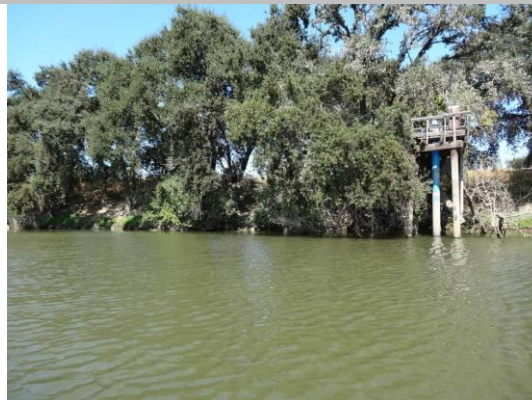
Photo 2 of 3 : FA\_2018\_RD0544\_109\_11\_20180906\_00013.jpg

Front view of the site.

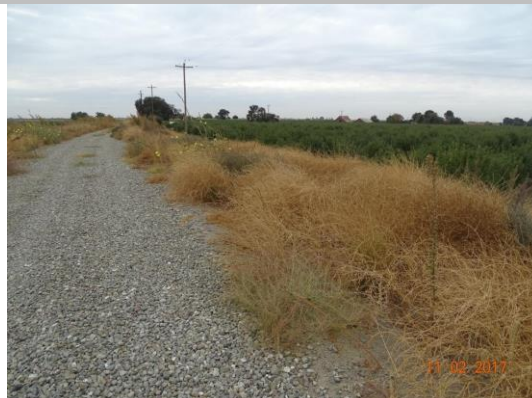
Photo 1 of 1 : FA\_2018\_RD0544\_109\_73\_20180906\_00056.jpg

LM Start	2.41	Rating **	U	Issue No.	73
LM End	2.59	Issue Type +	Ma	Location *	LS
Category	Earthen Levee			GPS Latitude/Longitude	
				Start	End
Item	Vegetation			37.821423 °	37.819153 °
				-121.348849 °	-121.350231 °
DWR ID	DWR_RD0544_02_f_2017_73				
Comment Code					
V2 : Remove the wild growth other than native grasses from the levee slopes.					
Inspector Comment

Looking southwest at the landside slope.

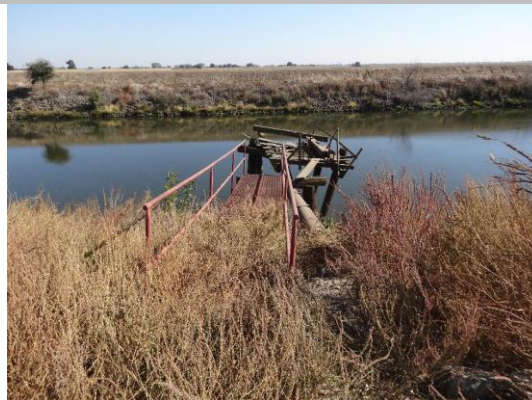
Photo 1 of 3 : UCIP\_FA\_2018\_51381\_42972.jpg

Comment Code						
Inspector Comment						
FS_ID:51381 DS_ID:22678 EP_NO: 8625A Repair Type: Non-Urgent Crossing Status: Found UCIP Comments: - abandoned crossing. Needs proper abandonment.- pump removed. Pipe discontinued on landside.- pile structure in dilapalated condon. FIELD_STRUCT_DESC: 16-inch coated steel irrigation discharge pipe through the levee, 7 feet below the crown. Pump mounted on a pile structure in the stream. Siphon breaker on the landside (LS) shoulder. Power pole on the LS slope. (Retention of an existing 16-inch irrigation pipe and pump through the levee authorized under Permit No. 8625-A, 1973 - Irvin Muller). [Additional Reference(s): DWR Levee Log, 2005. USACE San Joaquin O&M Manual 7, April 1964, (HLM 2.65), referenced as 10 feet below the crown]. FS Date: 10/31/2013

WS view: dilapidated walkway and pile structure. Pump removed.

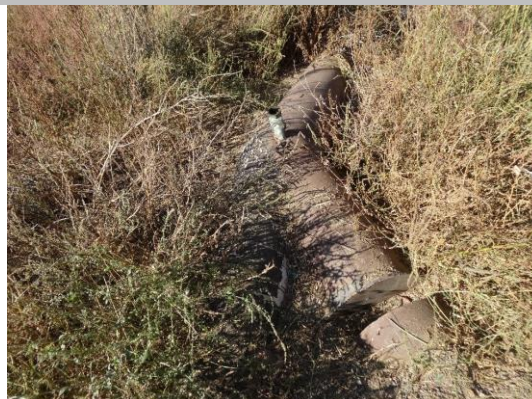
Photo 2 of 3 : UCIP\_FA\_2018\_51381\_42971.jpg

LS view: steel pipe cut out and discontinued (bottom).

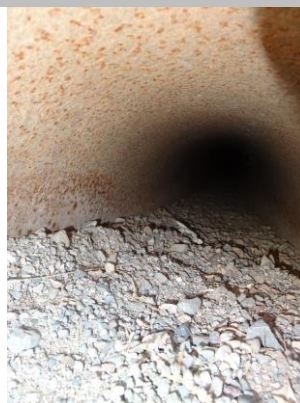
Photo 3 of 3 : UCIP\_FA\_2018\_51381\_42970.jpg

Comment Code						
Inspector Comment						
FS_ID:51381 DS_ID:22678 EP_NO: 8625A Repair Type: Non-Urgent Crossing Status: Found UCIP Comments: - abandoned crossing. Needs proper abandonment.- pump removed. Pipe discontinued on landside.- pile structure in dilapalated condon. FIELD_STRUCT_DESC: 16-inch coated steel irrigation discharge pipe through the levee, 7 feet below the crown. Pump mounted on a pile structure in the stream. Siphon breaker on the landside (LS) shoulder. Power pole on the LS slope. (Retention of an existing 16-inch irrigation pipe and pump through the levee authorized under Permit No. 8625-A, 1973 - Irvin Muller). [Additional Reference(s): DWR Levee Log, 2005. USACE San Joaquin O&M Manual 7, April 1964, (HLM 2.65), referenced as 10 feet below the crown]. FS Date: 10/31/2013

LS view: inside view of cut open pipe.

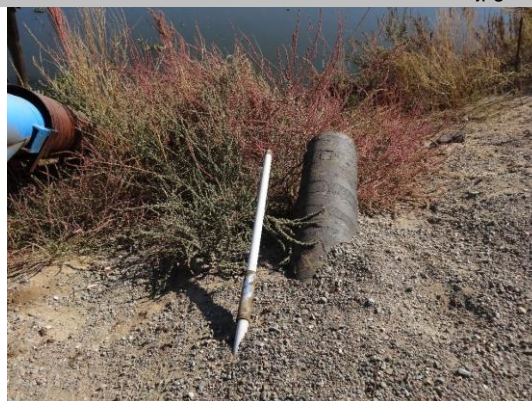
Photo 1 of 3 : UCIP\_FA\_2018\_53173\_42977.jpg

Comment Code					
Inspector Comment					
FS_ID:53173 DS_ID:24718 EP_NO: N/A Repair Type: Non-Urgent Crossing Status: Found UCIP Comments: 10/2/2018 Same as last inspection; downgrading to Non-Urgent due to no visual pipe or levee integrity threat (D. Sanoski - DWR UCIP).12/22/2016: Pipe is open on both ends and requires either proper abandonment or flap gate and closure device. Crossing has been upgraded from Non-Urgent to Urgent. (K. Fazel - UCIP)10/31/2013:- needs proper abandonment or closer of pipe end. (P. Amatya - DWR) FIELD_STRUCT_DESC: 14-inch steel pipe of an unknown purpose through the levee, 2 feet below the crown. Pipe open on both ends. 1-inch open conduit also at this location. This crossing was field discovered. FS Date: 10/2/2018 4:13:47 PM

WS view: steel pipe and electric conduit on levee shoulder.

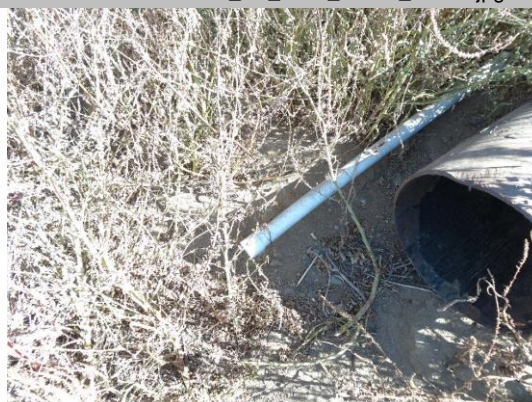
Photo 2 of 3 : UCIP\_FA\_2018\_53173\_42976.jpg

LS view: steel pipe and electric conduit on levee shoulder.

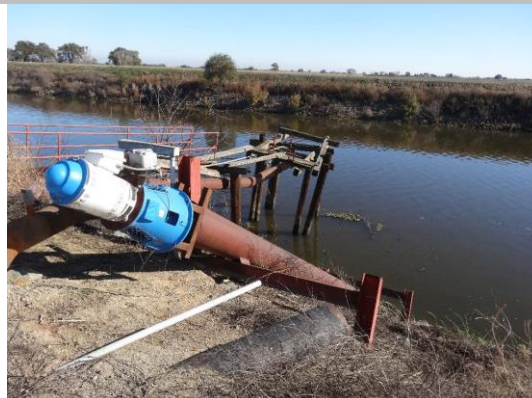
Photo 3 of 3 : UCIP\_FA\_2018\_53173\_76632.jpg

Comment Code						
Inspector Comment						
FS_ID:53173 DS_ID:24718 EP_NO: N/A Repair Type: Non-Urgent Crossing Status: Found UCIP Comments: 10/2/2018 Same as last inspection; downgrading to Non-Urgent due to no visual pipe or levee integrity threat (D. Sanoski - DWR UCIP).12/22/2016: Pipe is open on both ends and requires either proper abandonment or flap gate and closure device. Crossing has been upgraded from Non-Urgent to Urgent. (K. Fazel - UCIP)10/31/2013:- needs proper abandonment or closer of pipe end. (P. Amatya - DWR) FIELD_STRUCT_DESC: 14-inch steel pipe of an unknown purpose through the levee, 2 feet below the crown. Pipe open on both ends. 1-inch open conduit also at this location. This crossing was field discovered. FS Date: 10/2/2018 4:13:47 PM

WS view

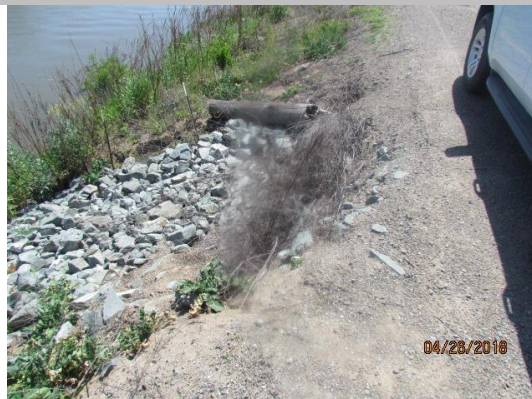
Photo 1 of 5 : FA\_2018\_RD0544\_109\_69\_20180906\_00047.jpg

LM Start	2.61	Rating **	U	Issue No.	69
LM End	2.61	Issue Type +	Ma	Location *	WS
Category	Earthen Levee			GPS Latitude/Longitude	
				Start	End
Item	Erosion / Bank Caving			37.818806 °	37.818806 °
				-121.350437 °	-121.350437 °
DWR ID	DWR_RD0544_02_f_2016_69				
Comment Code					
E2 : Schedule repair of erosion site prior to the next inspection.					
Inspector Comment					
Erosion greater than 1' deep and greater than 3' wide. Owner backfilled erosion with rock 3/4 filled. Still need to backfill the remaining erosion.

Looking south at erosion on shoulder. (Spring 2018)

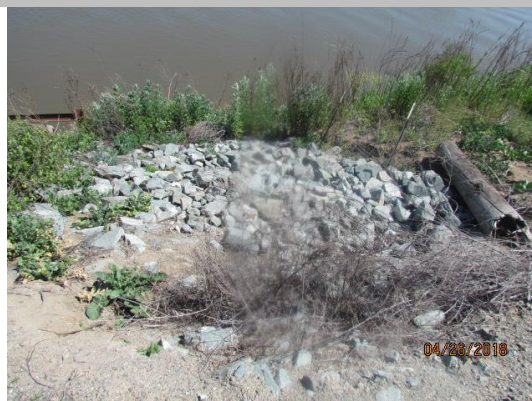
Photo 2 of 5 : FA\_2018\_RD0544\_109\_69\_20180906\_00048.jpg

LM Start	2.61	Rating **	U	Issue No.	69 (cont)	
LM End	2.61	Issue Type +	Ma	Location *	WS	
Category	Earthen Levee			GPS Latitude/Longitude		
				Start		End
Item	Erosion / Bank Caving			37.818806 °	37.818806 °	
				-121.350437 °	-121.350437 °	
DWR ID	DWR_RD0544_02_f __ 2016_69					
Comment Code						
E2 : Schedule repair of erosion site prior to the next inspection.						
Inspector Comment						
Erosion greater than 1' deep and greater than 3' wide. Owner backfilled erosion with rock 3/4 filled. Still need to backfill the remaining erosion.

Looking east at erosion on waterward slope. (Spring 2018)

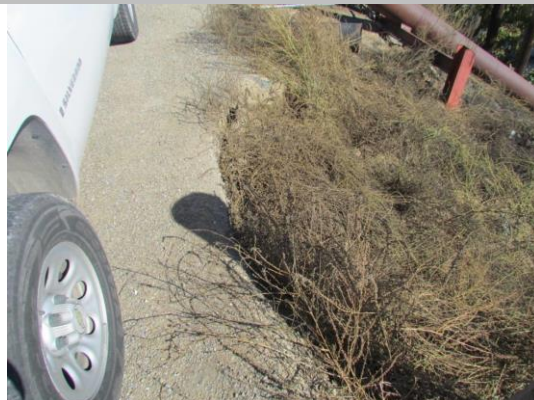
Photo 5 of 5 : FA\_2018\_RD0544\_109\_69\_20180906\_00051.jpg

LM Start	2.61	Rating **	U	Issue No.	69 (cont)	
LM End	2.61	Issue Type +	Ma	Location *	WS	
Category	Earthen Levee			GPS Latitude/Longitude		
				Start		End
Item	Erosion / Bank Caving			37.818806 °		37.818806 °
				-121.350437 °		-121.350437 °
DWR ID	DWR_RD0544_02_f _ 2016_69					
Comment Code						
E2 : Schedule repair of erosion site prior to the next inspection.						
Inspector Comment						
Erosion greater than 1' deep and greater than 3' wide. Owner backfilled erosion with rock 3/4 filled. Still need to backfill the remaining erosion.

Looking north at erosion on waterward shoulder and slope.

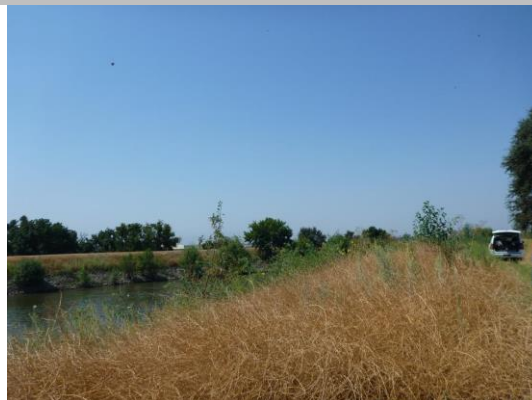
Comment Code						
Inspector Comment						
Levee Evaluation Comments						
Description:Slope protection repairs are needed along the waterside slope due to erosion and riprap displacement from high water. Based upon levee inspections, it was determined the waterside levee slope is eroding, deteriorating, and degrading. The eroded levee sections need to be restored back to design standards to prevent further deterioration and damage.						
Site ID No:547						
Site Designation:LMA-453						
Repair Type: Erosion						
Rating:Area of Concern						
Field Date:8/18/2017						
Notes: levee slopes covered in dense vegetations that hindered visibility.

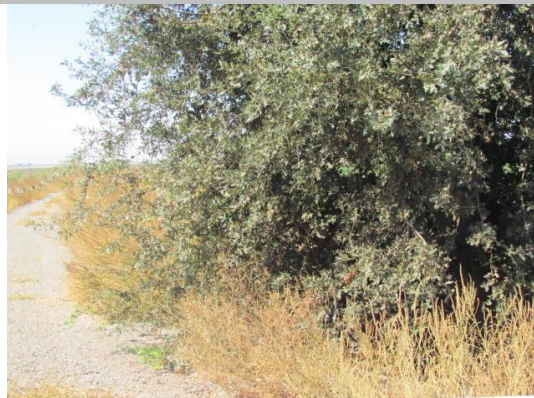
Photo 1 of 1 : FA\_2018\_RD0544\_109\_53\_20180906\_00038.jpg

LM Start	2.80	Rating **	M	Issue No.	53
LM End	2.80	Issue Type +	Ma	Location *	LS
Category	Earthen Levee			GPS Latitude/Longitude	
				Start	End
Item	Trim / Thin Trees			37.817187°	37.817187°
				-121.352964°	-121.352964°
DWR ID	DWR_RD0544_02_f_2014_53				
Comment Code					
T2 : Thin trees to allow visibility of the ground and room to flood fight.					
Inspector Comment

Looking southwest at untrimmed tree on landward slope fall 2015.

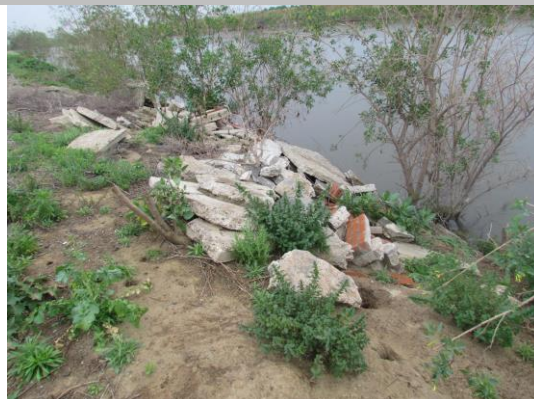
Photo 1 of 1 : FA\_2018\_RD0544\_109\_77\_20180906\_00057.jpg

LM Start	3.10	Rating **	U	Issue No.	77
LM End	3.10	Issue Type +	Ma	Location *	WS
Category	Earthen Levee			GPS Latitude/Longitude	
				Start	End
Item	Erosion / Bank Caving			37.817588°	37.817588°
				-121.358352°	-121.358352°
DWR ID	DWR_RD0544_02_s_2017_77				
Comment Code					
E1 : Note and monitor erosion site.					
Inspector Comment					
Rip rap was placed but does not meet Title 23 standards.

Looking northeast at concrete rubble on waterward slope.

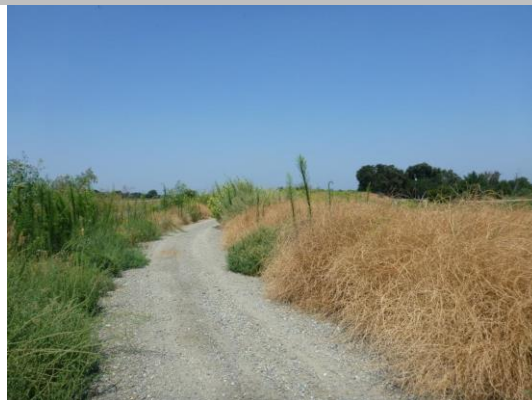
Comment Code					
Inspector Comment					
Levee Evaluation Comments					
Description:Slope protection repairs are needed along the waterside slope due to erosion and riprap displacement from high water. Based upon levee inspections, it was determined the waterside levee slope is eroding, deteriorating, and degrading. The eroded levee sections need to be restored back to design standards to prevent further deterioration and damage.					
Site ID No:546					
Site Designation:LMA-452					
Repair Type: Erosion					
Rating:Area of Concern					
Field Date:8/18/2017					
Notes: dense vegetations on both sides of the levee made the slopes inaccessible

Item	2017 Storm Damage			37.817700°	37.817800°
				-121.358600°	-121.358700°
DWR ID	DWR_RD0544_02_f_2017_92				
Comment Code					
Inspector Comment					
<p>Levee Evaluation Comments</p> <p>Description: Slope protection repairs are needed along the waterside slope due to erosion and riprap displacement from high water. Based upon levee inspections, it was determined the waterside levee slope is eroding, deteriorating, and degrading. The eroded levee sections need to be restored back to design standards to prevent further deterioration and damage.</p> <p>Site ID No: 546</p> <p>Site Designation: LMA-452</p> <p>Repair Type: Erosion</p> <p>Rating: Area of Concern</p> <p>Field Date: 8/18/2017</p> <p>Notes: dense vegetations on both sides of the levee made the slopes inaccessible</p>

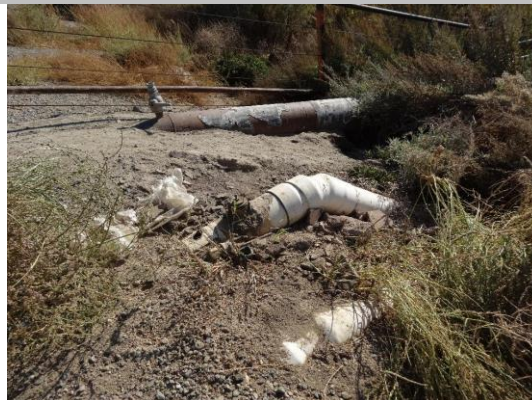
Photo 1 of 3 : UCIP\_FA\_2018\_24908\_44898.jpg

Comment Code						
Inspector Comment						
FS_ID:24908 DS_ID:22679 EP_NO: 16972 Repair Type: Non-Urgent Crossing Status: Found UCIP Comments: Pump not found on the waterward side.Damaged pipe-plug on waterside. Pipe exposed on both sides of the levee. FIELD_STRUCT_DESC: 1 of 2: 8-inch polyvinyl chloride (PVC) drainage discharge pipe through the levee, 2 feet below the crown. Siphon breaker on the waterside (WS). Pump on a steel platform in a drainage ditch. (Plans to replace the existing 6-inch drainage pipeline with a 14-inch steel pipeline and to replace two existing 8-inch pipelines with two 8-inch drainage discharge pipelines through the levee authorized under Permit No. 16972, 1999 - Joseph I. and Gayle Muller, TR). [Additional Reference(s): DWR Levee Log, 2005]. FS Date: 10/31/2013

WS view: 12" steel pipe (top), two 8" white pvc pipes (bottom) on levee shoulder.

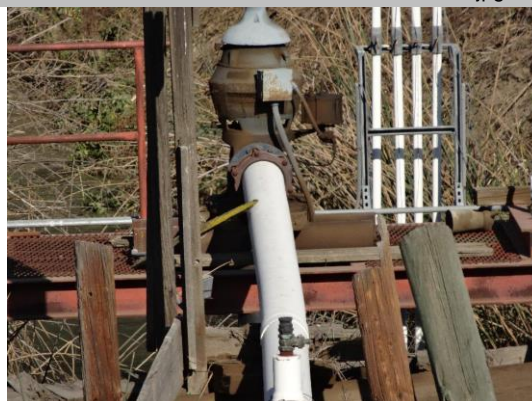
Photo 3 of 3 : UCIP\_FA\_2018\_24908\_44896.jpg

Comment Code						
Inspector Comment						
FS_ID:24908 DS_ID:22679 EP_NO: 16972 Repair Type: Non-Urgent Crossing Status: Found UCIP Comments: Pump not found on the waterward side.Damaged pipe-plug on waterside. Pipe exposed on both sides of the levee. FIELD_STRUCT_DESC: 1 of 2: 8-inch polyvinyl chloride (PVC) drainage discharge pipe through the levee, 2 feet below the crown. Siphon breaker on the waterside (WS). Pump on a steel platform in a drainage ditch. (Plans to replace the existing 6-inch drainage pipeline with a 14-inch steel pipeline and to replace two existing 8-inch pipelines with two 8-inch drainage discharge pipelines through the levee authorized under Permit No. 16972, 1999 - Joseph I. and Gayle Muller, TR). [Additional Reference(s): DWR Levee Log, 2005]. FS Date: 10/31/2013

LS view: pump on steel platform over drainage ditch.

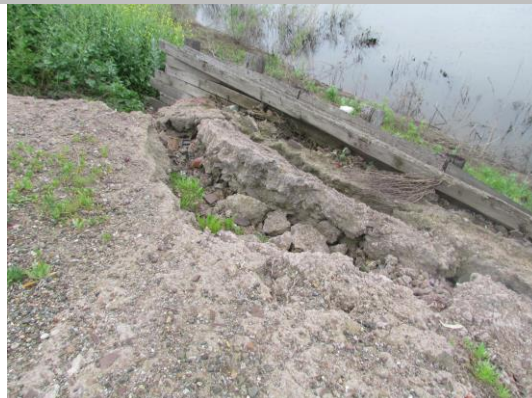
Photo 1 of 1 : FA\_2018\_RD0544\_109\_78\_20180906\_00058.jpg

LM Start	3.25	Rating **	U	Issue No.	78
LM End	3.25	Issue Type +	En	Location *	WS
Category	Earthen Levee			GPS Latitude/Longitude	
				Start	End
Item	Encroachments			37.819347 °	37.819347 °
				-121.360103 °	-121.360103 °
DWR ID	DWR_RD0544_02_s_2017_78				
Comment Code					
RW : Retaining Wall					
Inspector Comment					
Waterside slope retaining wall at pump location has slipped.

Looking east at sloughing of earthen pad on waterward shoulder and slope.

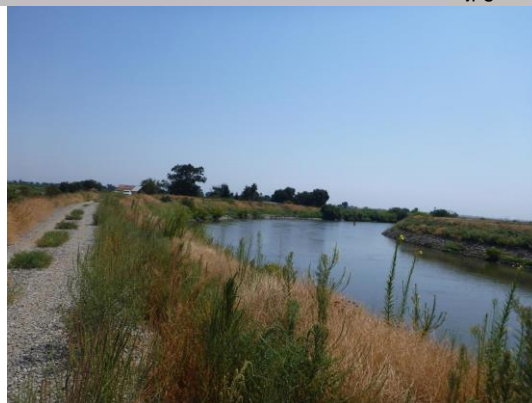
Photo 1 of 3 : LEVAL\_FA\_2018\_545\_4707.jpg

LM Start	3.25	Rating **	A/W	Issue No.	93
LM End	3.34	Issue Type +	Ma	Location *	
Category	Supplemental			GPS Latitude/Longitude	
				Start	End
Item	2017 Storm Damage			37.819300 °	37.819800 °
				-121.360200 °	-121.361600 °
DWR ID	DWR_RD0544_02_f_2017_93				
Comment Code					
Inspector Comment					
Levee Evaluation Comments					
Description:Slope protection repairs are needed along the waterside slope due to erosion and riprap displacement from high water. Based upon levee inspections, it was determined the waterside levee slope is eroding, deteriorating, and degrading. The eroded levee sections need to be restored back to design standards to prevent further deterioration and damage.					
Site ID No:545					
Site Designation:LMA-451					
Repair Type: Erosion					
Rating:Area of Concern					
Field Date:8/18/2017					
Notes:

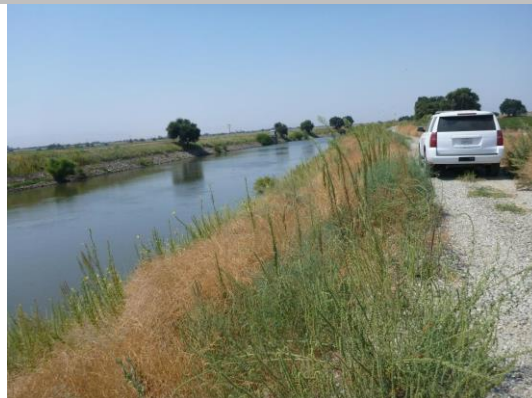
Photo 2 of 3 : LEVAL\_FA\_2018\_545\_4712.jpg

LM Start	3.25	Rating **	A/W	Issue No.	93 (cont)	
LM End	3.34	Issue Type +	Ma	Location *		
Category	Supplemental			GPS Latitude/Longitude		
				Start	End	
Item	2017 Storm Damage			37.819300 °	37.819800 °	
				-121.360200 °	-121.361600 °	
DWR ID	DWR_RD0544_02_f_2017_93					
Comment Code						
Inspector Comment						
Levee Evaluation Comments						
Description:Slope protection repairs are needed along the waterside slope due to erosion and riprap displacement from high water. Based upon levee inspections, it was determined the waterside levee slope is eroding, deteriorating, and degrading. The eroded levee sections need to be restored back to design standards to prevent further deterioration and damage.						
Site ID No:545						
Site Designation:LMA-451						
Repair Type: Erosion						
Rating:Area of Concern						
Field Date:8/18/2017						
Notes:

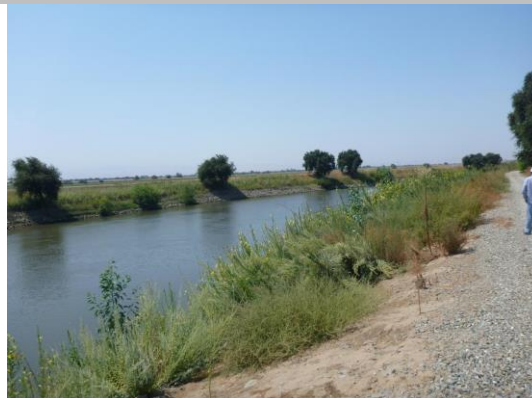
Photo 3 of 3 : LEVAL\_FA\_2018\_544\_4783.jpg

LM Start	3.51	Rating **	A/W	Issue No.	94 (cont)
LM End	3.55	Issue Type +	Ma	Location *	
Category	Supplemental			GPS Latitude/Longitude	
				Start	End
Item	2017 Storm Damage			37.819500 °	37.819400 °
				-121.364700 °	-121.365400 °
DWR ID	DWR_RD0544_02_f _ 2017_94				
Comment Code					
Inspector Comment					
Levee Evaluation Comments					
Description:Slope protection repairs are needed along the waterside slope due to erosion and riprap displacement from high water. Based upon levee inspections, it was determined the waterside levee slope is eroding, deteriorating, and degrading. The eroded levee sections need to be restored back to design standards to prevent further deterioration and damage.					
Site ID No:544					
Site Designation:LMA-450					
Repair Type: Erosion					
Rating:Area of Concern					
Field Date:8/18/2017					
Notes:

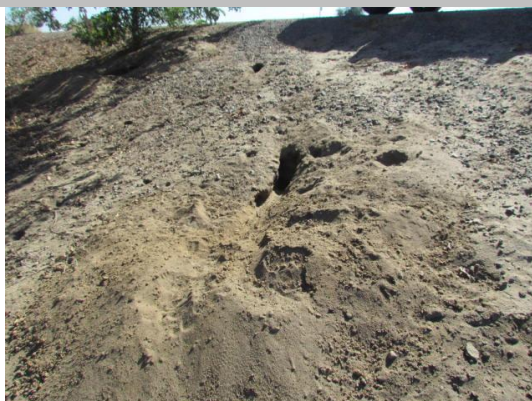
Photo 2 of 2 : FA\_2018\_RD0544\_109\_67\_20180906\_00045.jpg

LM Start	3.58	Rating **	M	Issue No.	67 (cont)	
LM End	3.58	Issue Type +	Ma	Location *	LS	
Category	Earthen Levee			GPS Latitude/Longitude		
				Start		End
Item	Animal Control			37.819419 °		37.819419 °
				-121.365854 °		-121.365854 °
DWR ID	DWR_RD0544_02_f_2015_67					
Comment Code						
A3 : No rodents visible, but rodent burrows visible; need to backfill and compact or grout burrows.						
Inspector Comment						
Large rodent holes on landward slope.

Looking north at typical view of rodent holes on landward slope.

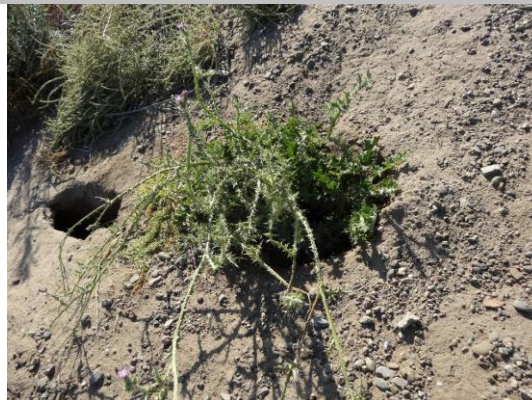
Photo 1 of 3 : UCIP\_FA\_2018\_53367\_43005.jpg

FS\_ID:53367  
DS\_ID:22674  
EP\_NO: 16357  
Repair Type: Urgent  
Crossing Status: Found  
UCIP Comments: 10/2/2018 Same as last inspection; WS pipe completely eroded away and therefore poses significant threat to internal levee integrity so crossing remains Urgent (D. Sanoski - DWR UCIP).12/22/2015 Entire top part of pipe on WS corroded through and completely gone. Difficult to see WS due to heavy vegetation. Gully formed on WS slope in alignment with pipe and WS slope is saturated. (K. Fazel - UCIP)06/25/2015 Pipe completely rusted thru on WS slope and has potential to cause great erosion. Pit and holes on pipe and levee. No vent pipe found on WS. No concrete vent pipe found at the LS toe. (K. Fazel - UCIP)  
FIELD\_STRUCT\_DESC: 10-inch steel drainage discharge pipe through the levee, 3 feet below the crown. Pump on a concrete sump at the landside (LS) toe. Power pole with transformer at the LS toe. Backflow prevention valve at the LS toe, next to the pump. Pipe is open on the waterside (WS) end. (Plans to place 7 feet of fill on the LS of the crown, to remove existing pump and pipe, to install two slant pumps with 10-inch intake pipes and a 14-inch pipe through the levee, and to place riprap on the WS levee slope authorized under Permit No. 16357, 1995 - Pacific Agrilands, Inc). [Additional Reference(s): DWR Levee Log, 2005, 12-inch pipe referenced, 8 feet below the crown. USACE San Joaquin O&M Manual 7, April 1964, (HLM 4.03), 12-inch pipe referenced, 8 feet below the crown].

WS view: levee slope with pits and holes.

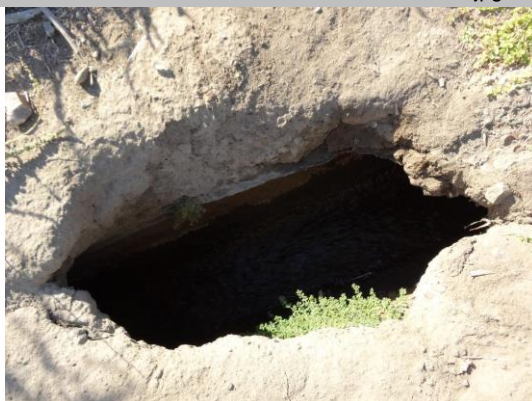
Photo 2 of 3 : UCIP\_FA\_2018\_53367\_43004.jpg

UCIP Comments: 10/2/2018 Same as last inspection; WS pipe completely eroded away and therefore poses significant threat to internal levee integrity so crossing remains Urgent (D. Sanoski - DWR UCIP). 12/22/2015 Entire top part of pipe on WS corroded through and completely gone. Difficult to see WS due to heavy vegetation. Gully formed on WS slope in alignment with pipe and WS slope is saturated. (K. Fazel - UCIP) 06/25/2015 Pipe completely rusted thru on WS slope and has potential to cause great erosion. Pit and holes on pipe and levee. No vent pipe found on WS. No concrete vent pipe found at the LS toe. (K. Fazel - UCIP)

WS view: close view of levee slope with pits and holes.

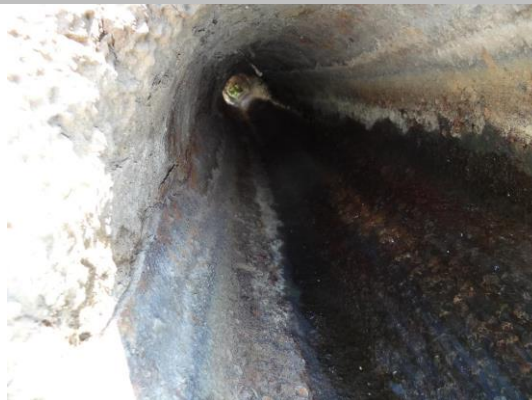
Photo 3 of 3 : UCIP\_FA\_2018\_53367\_43003.jpg

UCIP Comments: 10/2/2018 Same as last inspection; WS pipe completely eroded away and therefore poses significant threat to internal levee integrity so crossing remains Urgent (D. Sanoski - DWR UCIP). 12/22/2015 Entire top part of pipe on WS corroded through and completely gone. Difficult to see WS due to heavy vegetation. Gully formed on WS slope in alignment with pipe and WS slope is saturated. (K. Fazel - UCIP) 06/25/2015 Pipe completely rusted thru on WS slope and has potential to cause great erosion. Pit and holes on pipe and levee. No vent pipe found on WS. No concrete vent pipe found at the LS toe. (K. Fazel - UCIP)

WS view: inside view of hole in deteriorated pipe.
